# **Environmental Assessment Report**

**Roth Middle School  
4000 East Henrietta Road  
Henrietta, New York 14467**

**Rush-Henrietta Central School District  
1133 Lehigh Station Road  
Henrietta, New York 14467**

**Leader Professional Services, Inc.  
271 Marsh Road, Suite 2  
Pittsford, New York 14534**

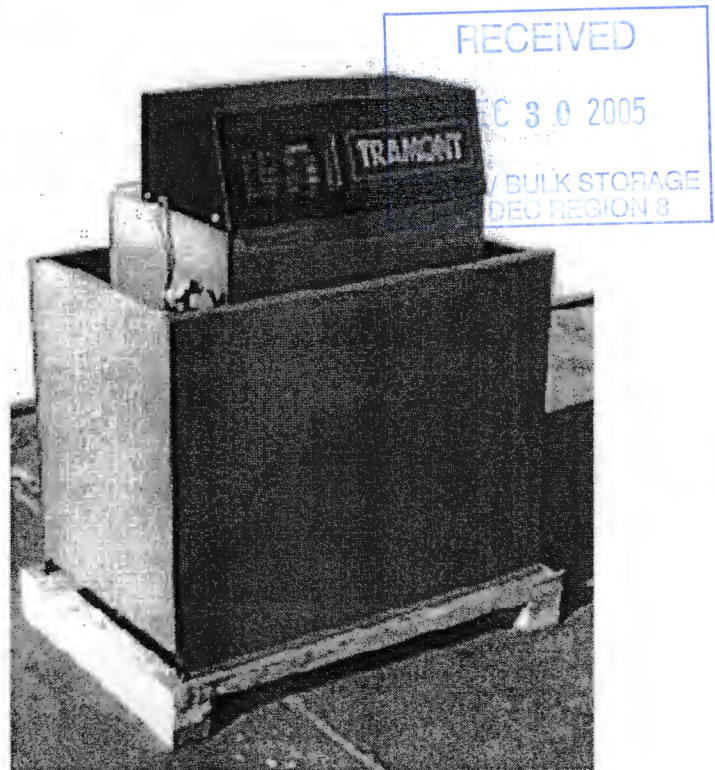
*The Tramont TRS Series day tank with optional rupture basin and fuel-in-basin alarm.*

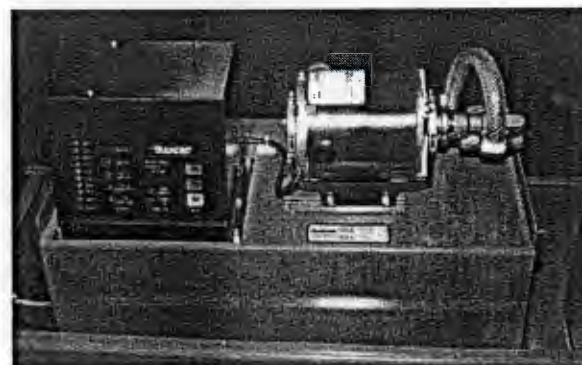
*TRS Series day tanks include the System 2000PLUS ECM, 1/3 HP motor and 2 GPM pump as standard features. A full line of optional features also are available.*

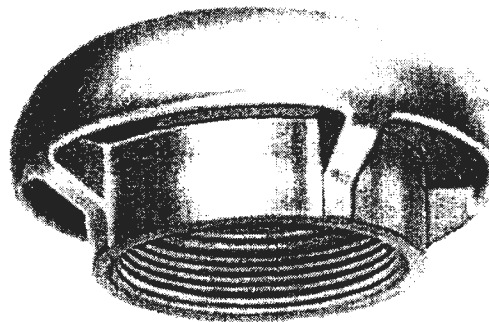
Mushroom style free flow vent is designed for atmospheric venting of diesel fuel tank. The normal vent cap is made of cast iron with a domed top to prevent tank contamination. A 30-mesh screen is securely inserted within the vent cap to prevent debris from entering the vent pipe or tank. Each cap is threaded for a positive stop.

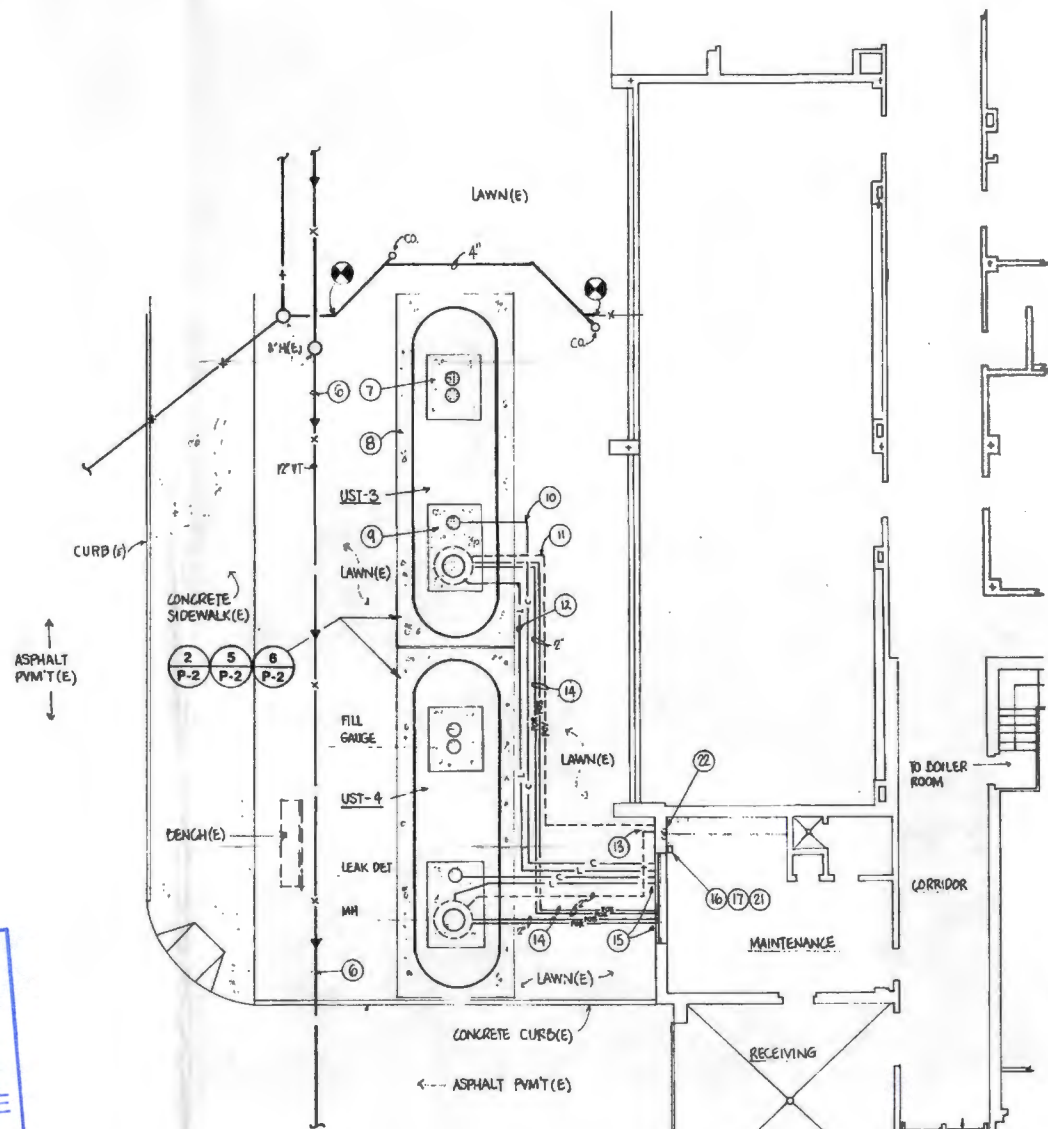
**PARTIAL SITE PLAN**  
 SCALE: 1/8"=1'-0"

- DRAWING SHEET P-1
- REMOVE TWO (2) EXISTING 10,000 GALLON UNDERGROUND OIL STORAGE TANKS COMPLETE INCLUDING CONCRETE PADS, STRAPS AND PIPING FROM TANKS TO INSIDE BUILDING. REFER TO DETAILS 11 OF SECTION P-3 FOR REMOVAL DETAILS.

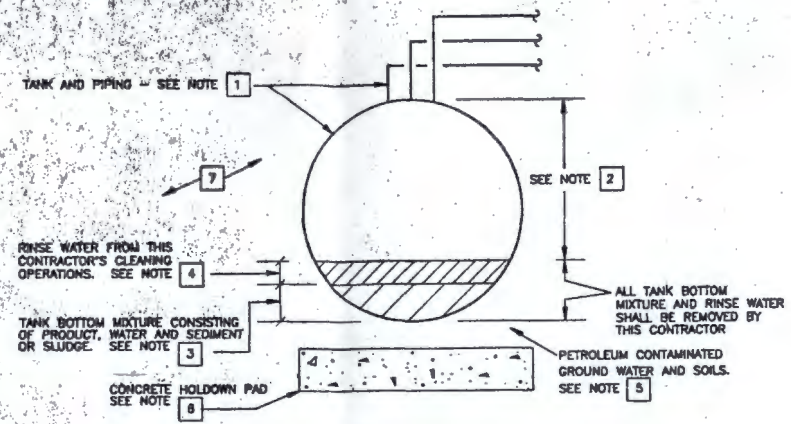
**TANK AND LIQUIDS REMOVAL** (1) P-2  
NO SCALE

- KEY NOTES FOR TANKS AND LIQUIDS REMOVAL DETAIL:**
- REMOVE AND LEGALLY DISPOSE OF ALL STORAGE TANKS, PIPING AND LIQUID/SEDIMENT WITHIN THE TANK IN ACCORDANCE TO NYS DEC REQUIREMENTS AND GUIDELINES, EPA REQUIREMENTS AND LOCAL AUTHORITIES HAVING JURISDICTION.

- THE SCHOOL DISTRICT HAS REMOVED THE MAJORITY OF FLUIDS FROM THE TANKS, HOWEVER, SOME LIQUIDS REMAIN. NO SEDIMENT OR SLUDGE HAS BEEN REMOVED FROM THE TANKS.
